BREAKING LOAD TEST CONVEYOR CHAIN CULLENS

Test Report No. 7191121180-MEC15-SL
dated 16 SEP 2015

Breaking Load Test on Conveyor Chain

The following samples claim to be "Cullens" brand were submitted by:

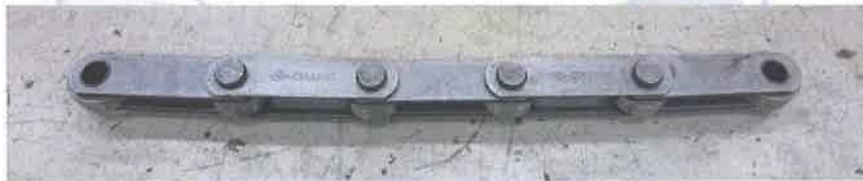
1. ST628 70,000lbs
2. ST628 50,000lbs
3. ST128 26,000lbs

Photo.1 – Typical Sample received

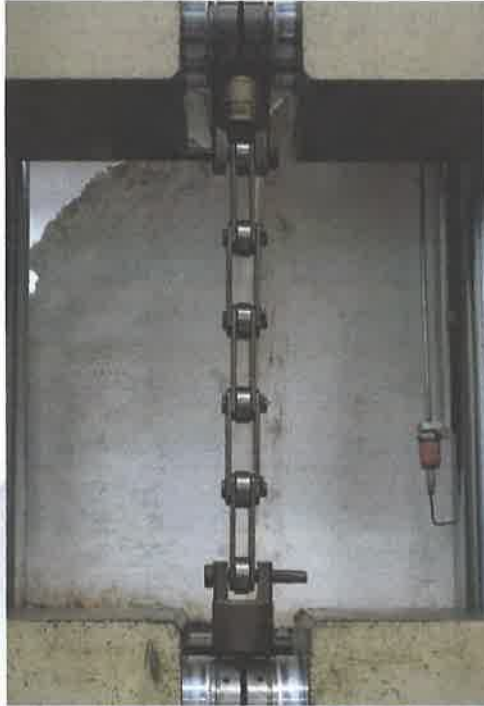
The conveyor chain was fitted to the test fixture held by the jaw of the Universal Machine (refer to photo 2). Tension load was gradually applied until failure occurred and the maximum force was then recorded.

Photo. 2 – Typical Test Set Up

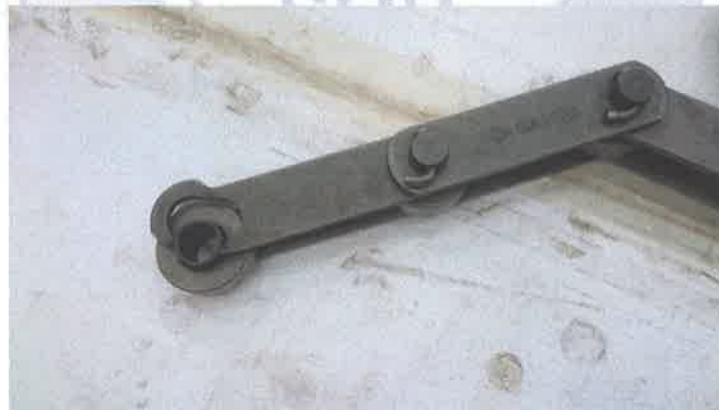
Sample reference	ST628 70,000lbs	ST628 50,000lbs	ST128 26,000lbs
Max Load (kN)	329.8	312.2	155.1
Mode of failure	Break at link plate (refer to photo 3)	Break at link plate (refer to photo 4)	Break at link plate (refer to photo 5)

Photo. 3 – Mode of failure (ST628 - 70,000lbs)

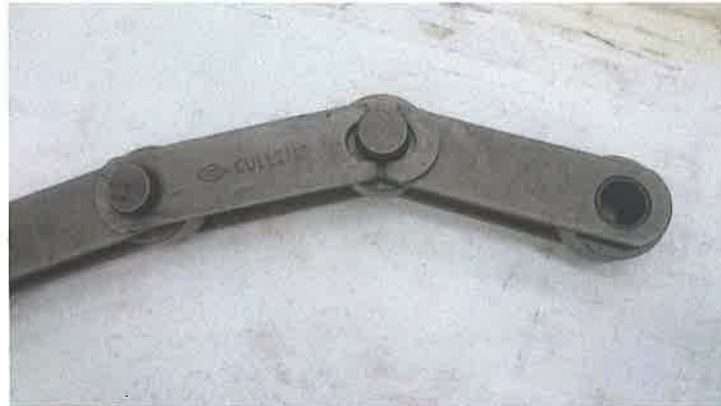
Photo. 4 – Mode of failure (ST628 - 50,000lbs)

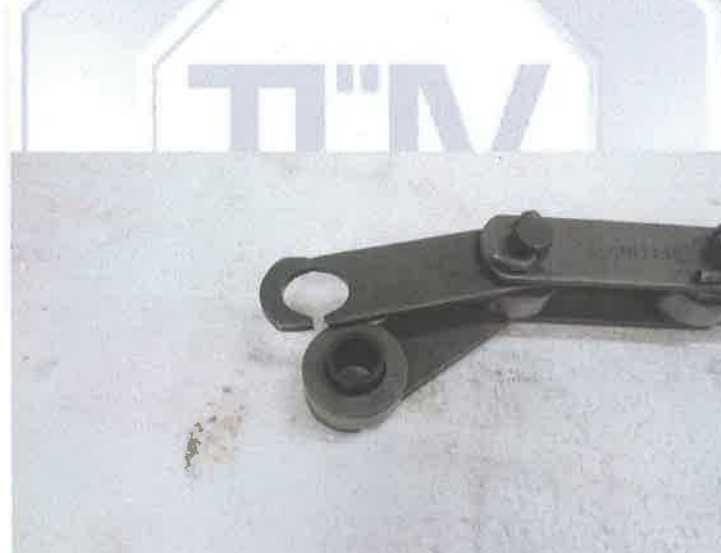
Photo. 4 – Mode of failure (ST128 - 26,000lbs)

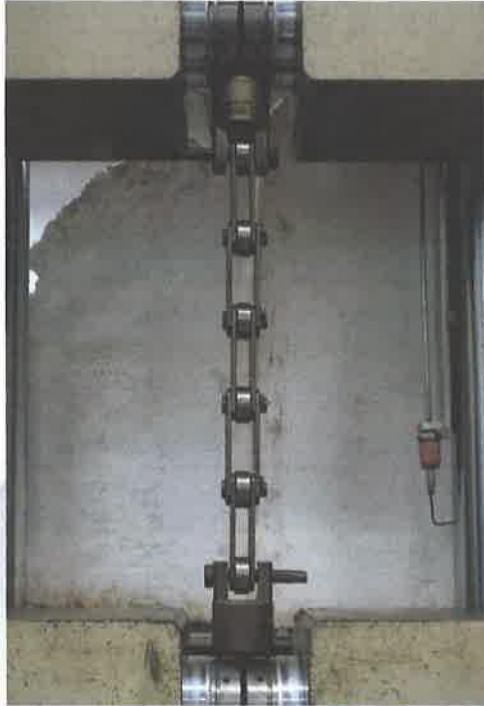
The conveyor chain was fitted to the test fixture held by the jaw of the Universal Machine (refer to photo 2). Tension load was gradually applied until failure occurred and the maximum force was then recorded.

Photo. 2 – Typical Test Set Up

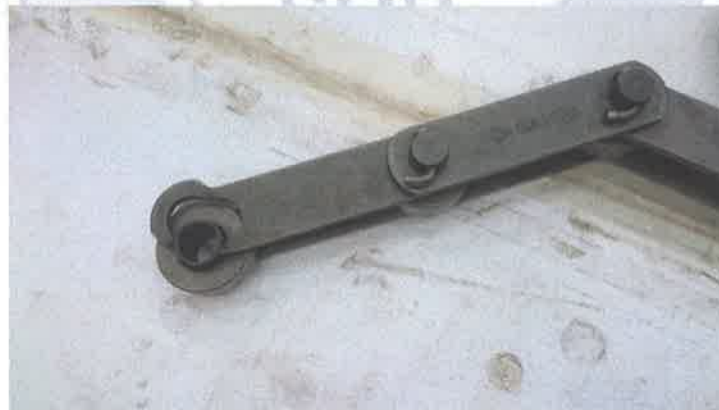
Sample reference	ST628 70,000lbs	ST628 50,000lbs	ST128 26,000lbs
Max Load (kN)	329.8	312.2	155.1
Mode of failure	Break at link plate (refer to photo 3)	Break at link plate (refer to photo 4)	Break at link plate (refer to photo 5)

Photo. 3 – Mode of failure (ST628 - 70,000lbs)

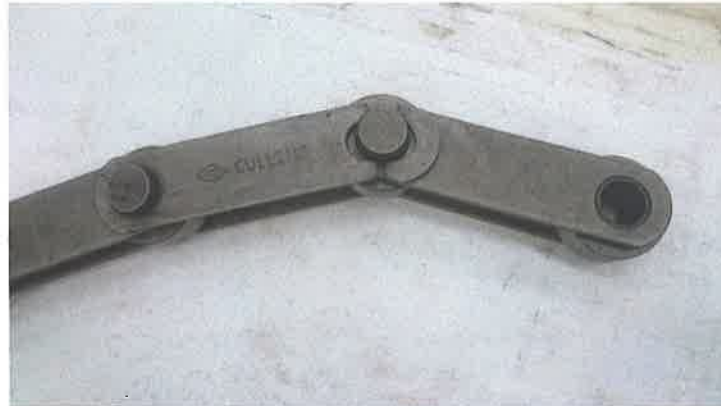
Photo. 4 – Mode of failure (ST628 - 50,000lbs)

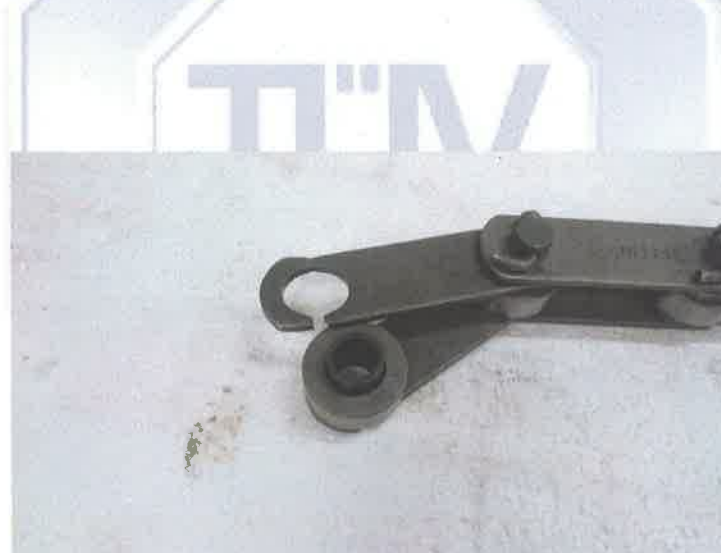
Photo. 4 – Mode of failure (ST128 - 26,000lbs)

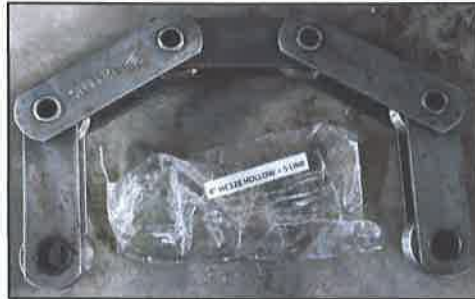
Photo 1: Sample received

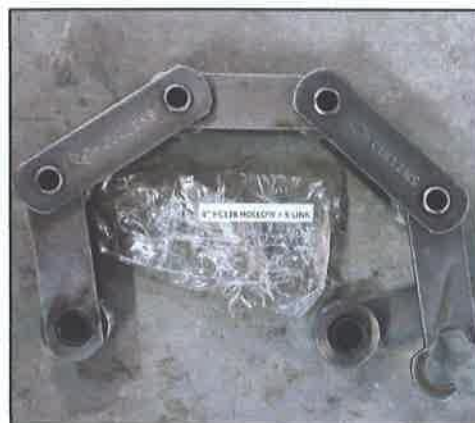
Photo 3: Sample after test

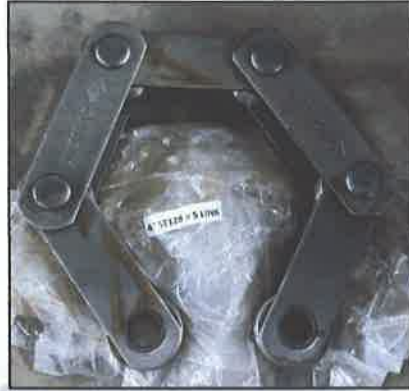
Photo 1: Sample received

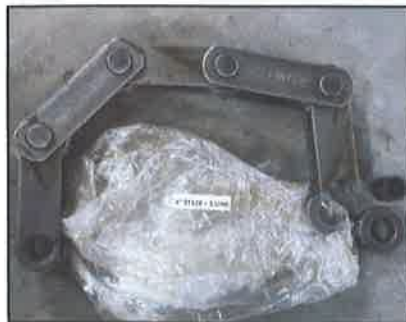
Photo 3: Sample after test

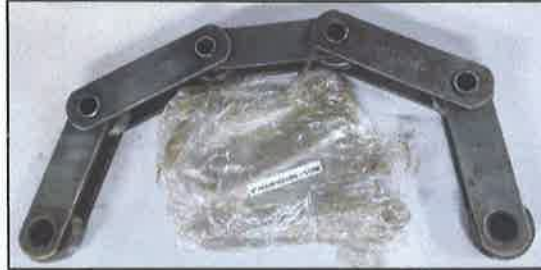
Photo 1: Sample received

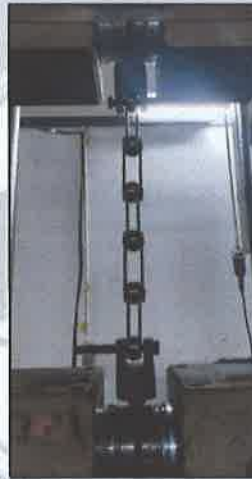
Both end of the conveyor chain was slot into the fixture. The fixture then placed on the Universal Testing Machine (UTM) and force was gradually applied until maximum load is recorded. Visual inspection was then observed after the test.

Photo 2: Test setup

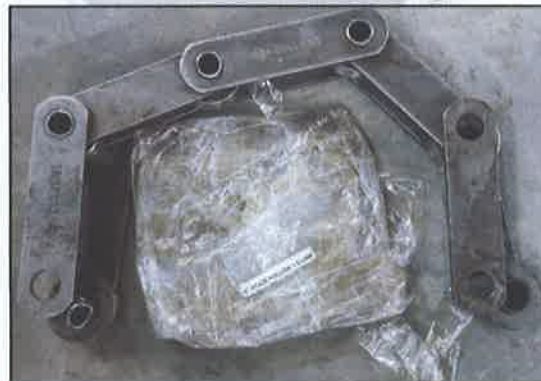
Photo 3: Sample after test

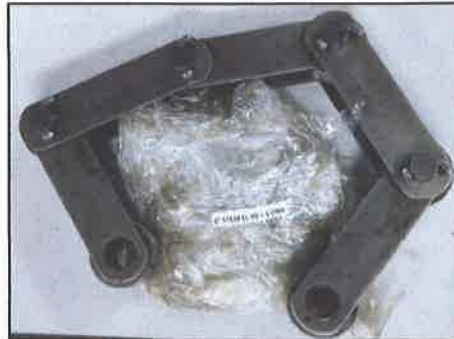
Photo 1: Sample received

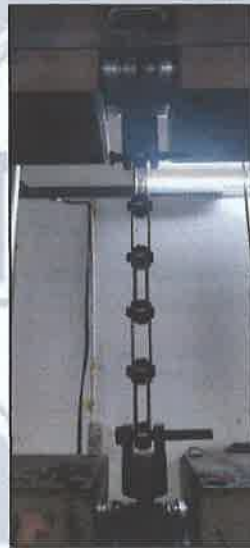
Both end of the conveyor chain was slot into the fixture. The fixture then placed on the Universal Testing Machine (UTM) and force was gradually applied until maximum load is recorded. Visual inspecton was then observed after the test.

Photo 2: Test setup

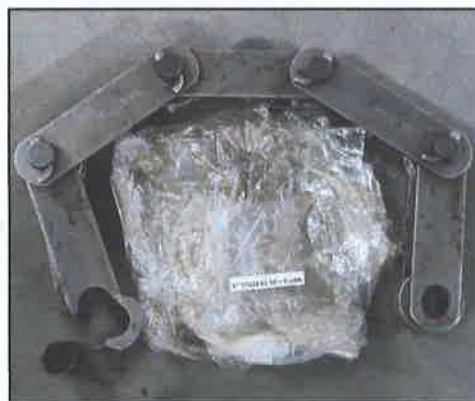
Photo 3: Sample after test

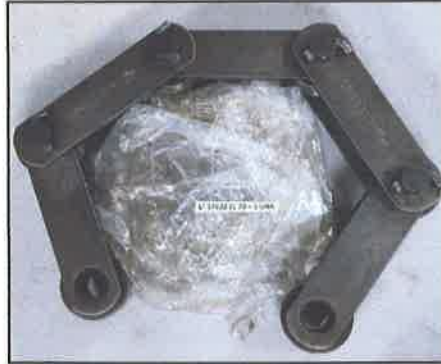
Photo 1: Sample received

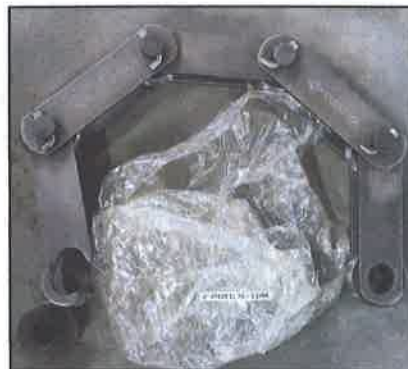
Photo 3: Sample after test

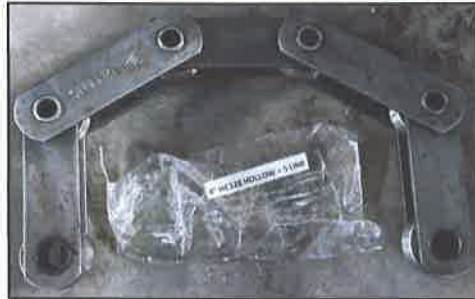
Photo 1: Sample received

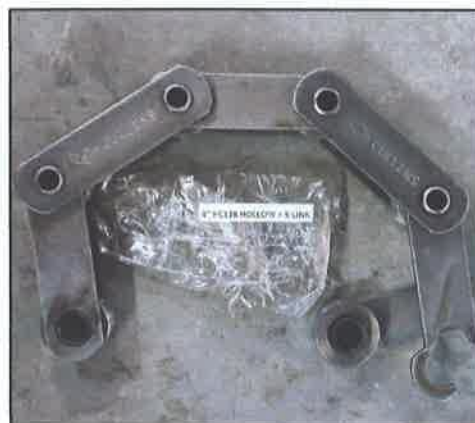
Photo 3: Sample after test

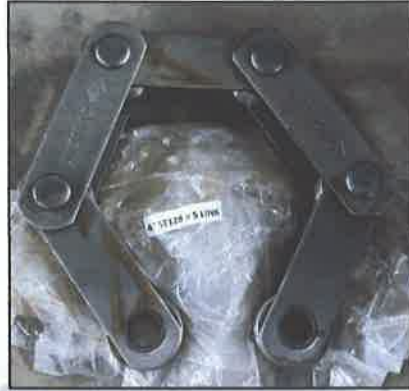
Photo 1: Sample received

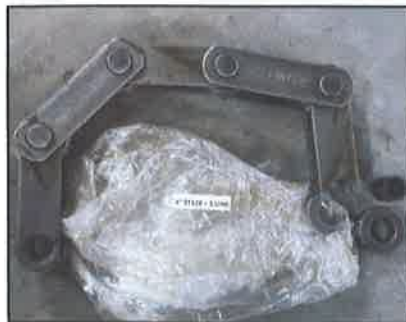
Photo 3: Sample after test

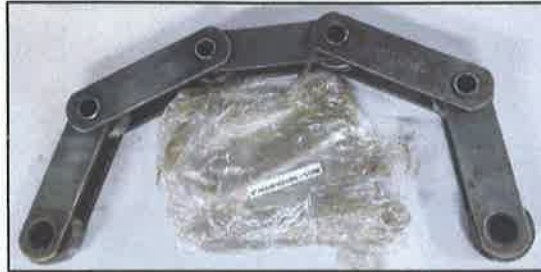
Photo 1: Sample received

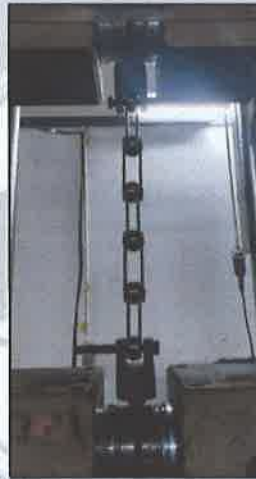
Both end of the conveyor chain was slot into the fixture. The fixture then placed on the Universal Testing Machine (UTM) and force was gradually applied until maximum load is recorded. Visual inspection was then observed after the test.

Photo 2: Test setup

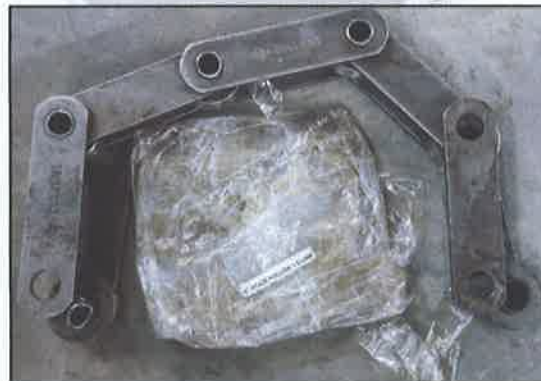
Photo 3: Sample after test

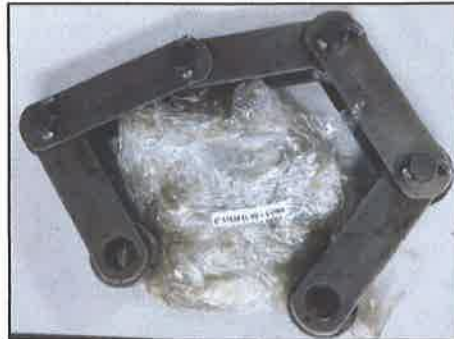
Photo 1: Sample received

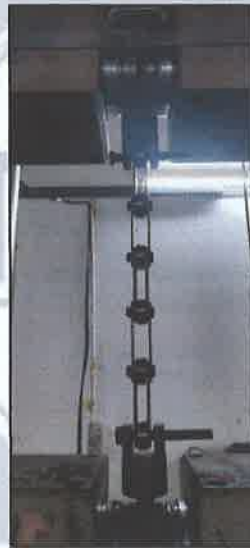
Both end of the conveyor chain was slot into the fixture. The fixture then placed on the Universal Testing Machine (UTM) and force was gradually applied until maximum load is recorded. Visual inspecton was then observed after the test.

Photo 2: Test setup

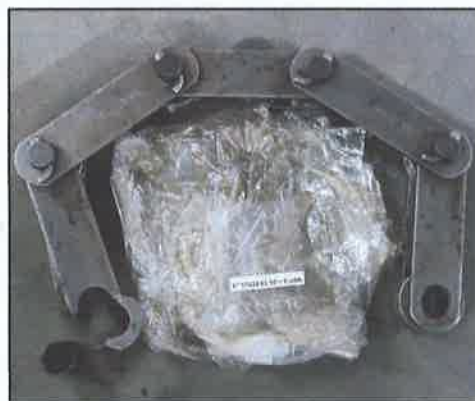
Photo 3: Sample after test

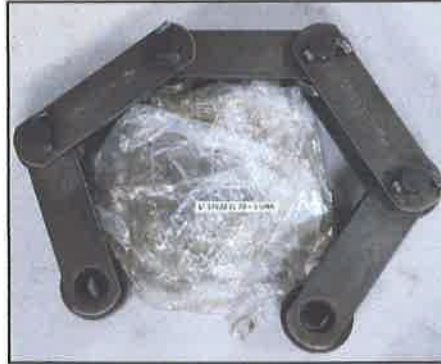
Photo 1: Sample received

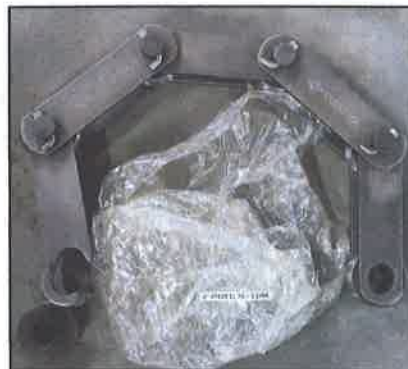
Photo 3: Sample after test
